**ATTACHMENT 2**

***OSIM INSPECTION REPORTS & BCI FORMS***

***CULVERTS***

**Structure Name** Forest Lake Road Culvert  
**Structure Number** BR2  
**Date of Inspection** August 04, 2020  
**Project No.** 20032  
**Consultant** HP Engineering Inc.

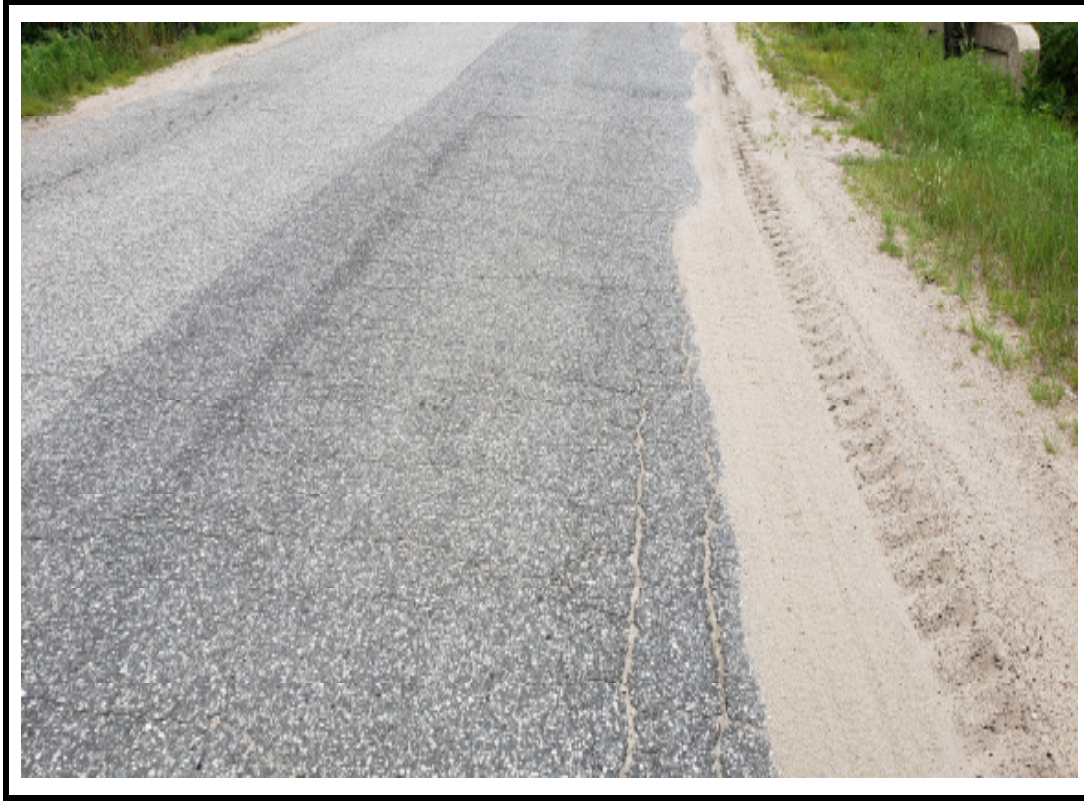
Photo 7 Horizontal and vertical cracks with tire rutting noted on wearing surface throughout

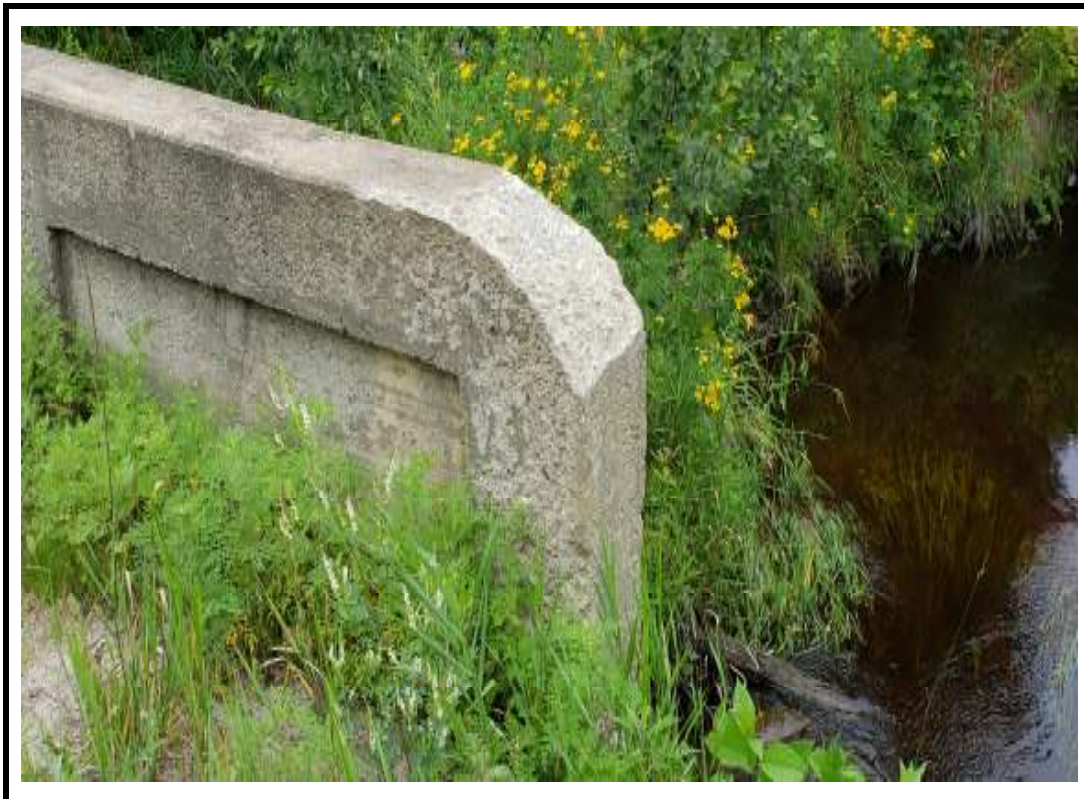
Photo 8 Moderate scaling noted on substandard traffic barrier

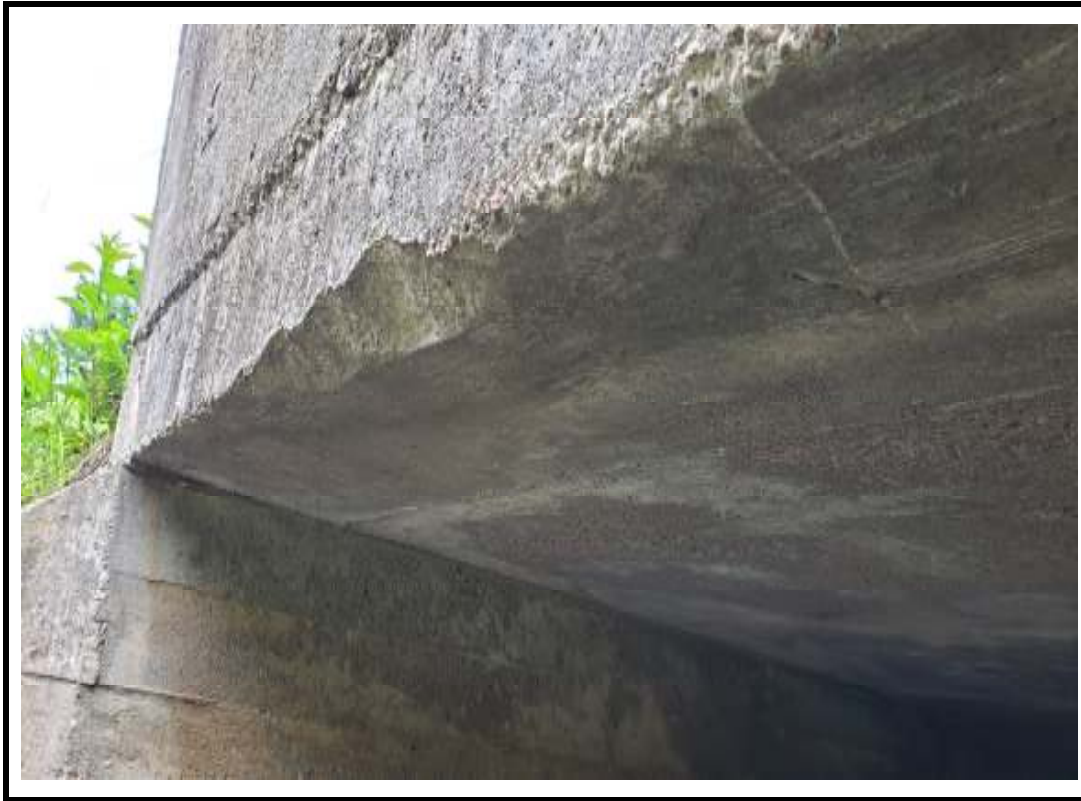
Photo 9 Spall noted on soffit at north end

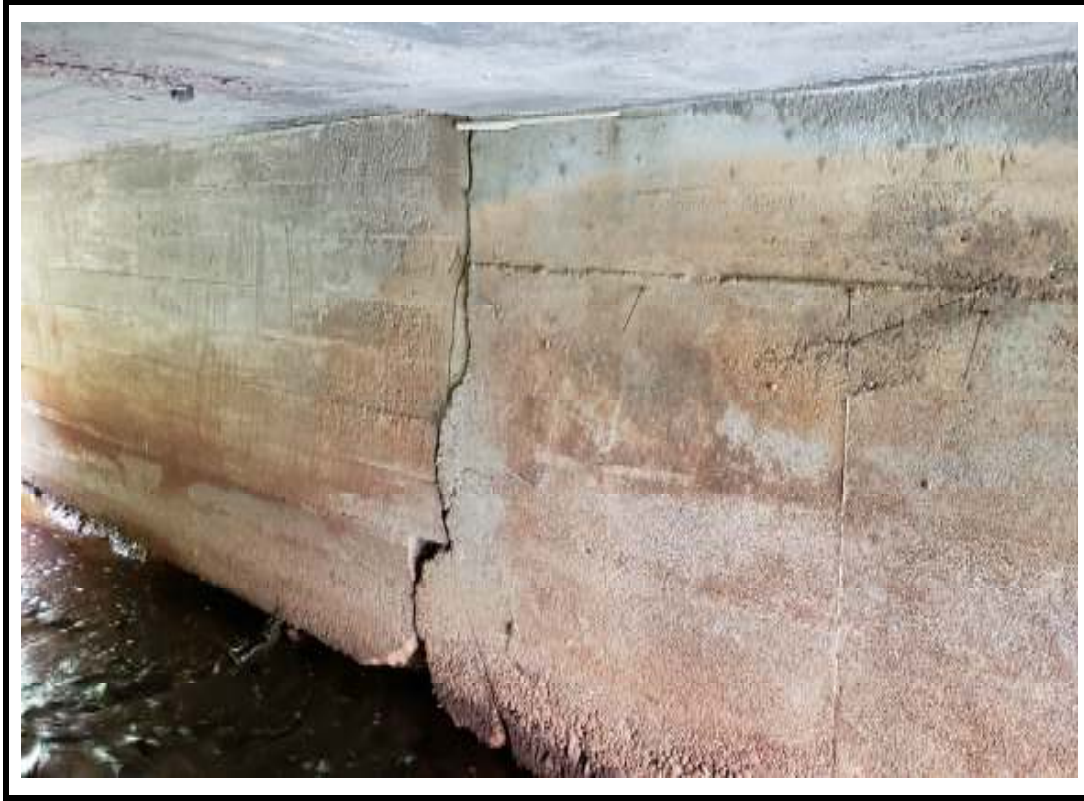
Photo 11 Full length crack and undermining noted on west abutment wall

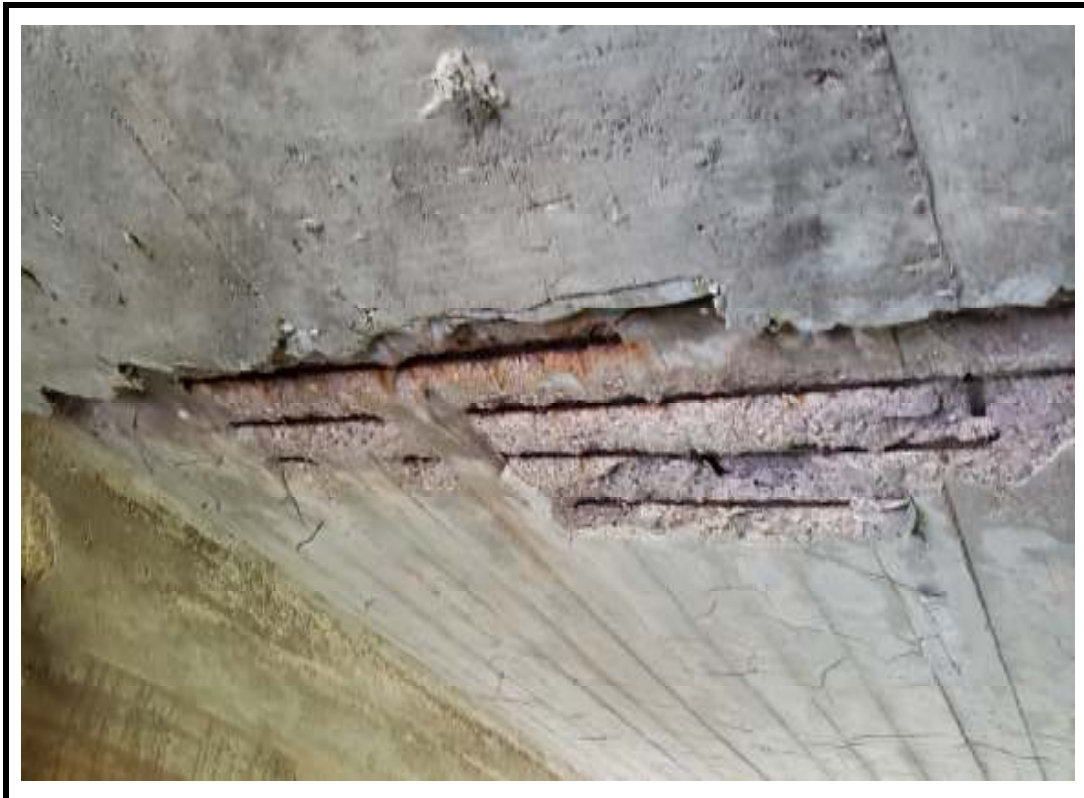
Photo 12 Large spalls with exposed corroded reinforcement noted on soffit at mid span

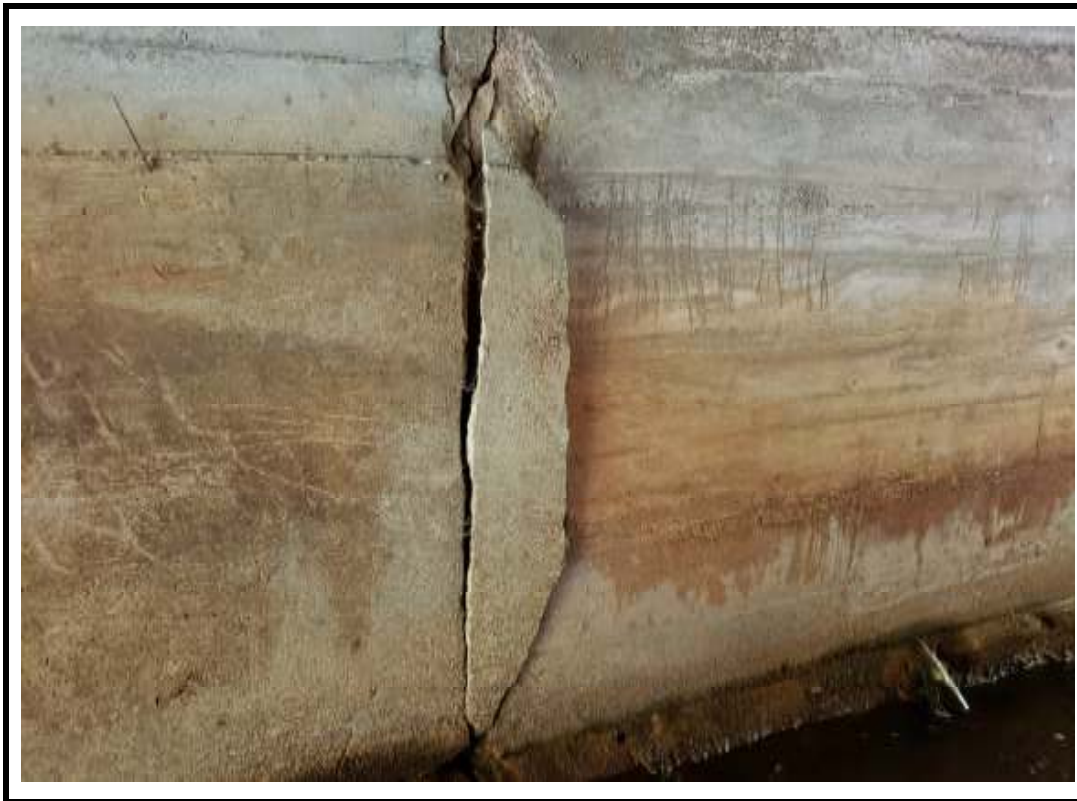
Photo 13 Large spall with portion coming out at construction joint on east abutment wall

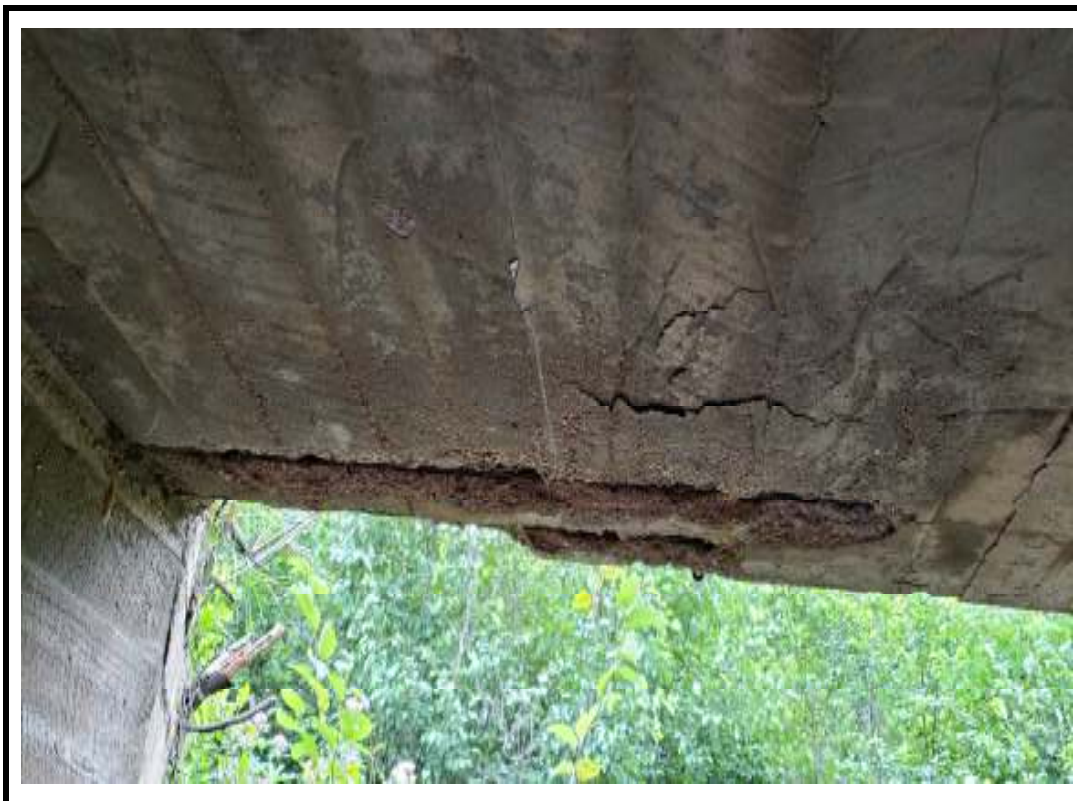
Photo 14 Delamination and spalls with exposed corroded reinforcement noted on soffit at south end

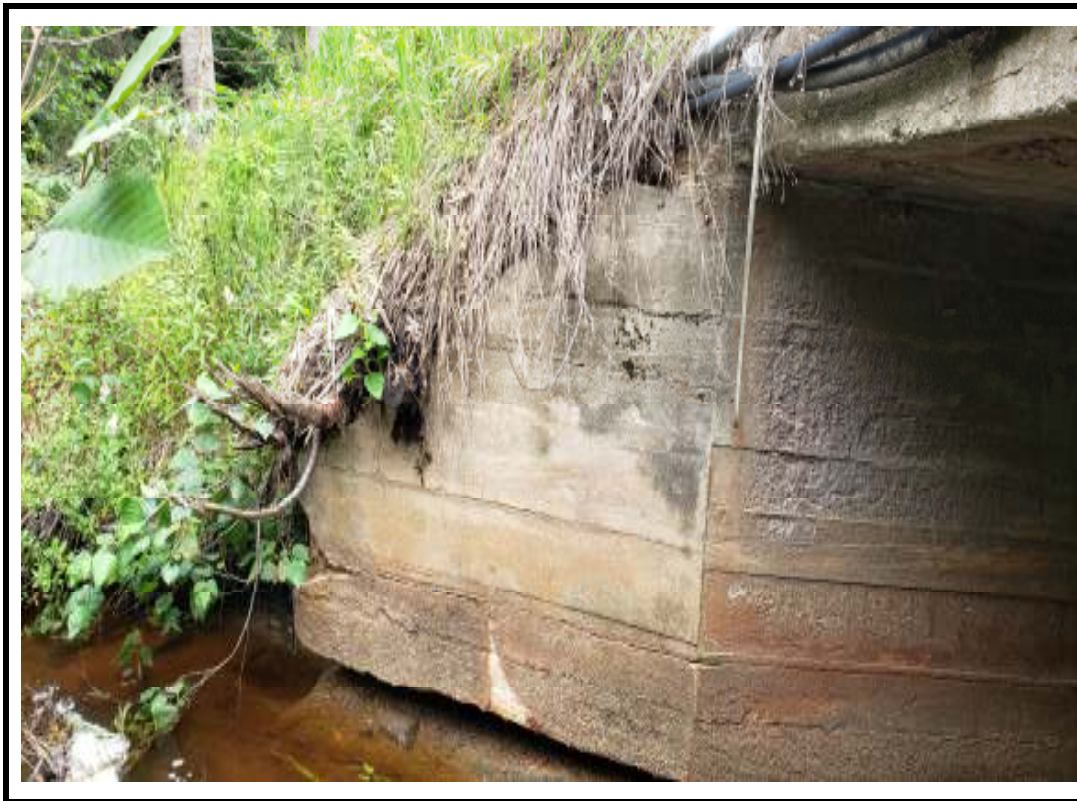
Photo 15 Moderate honeycombing, and undermining noted on southwest retaining wall

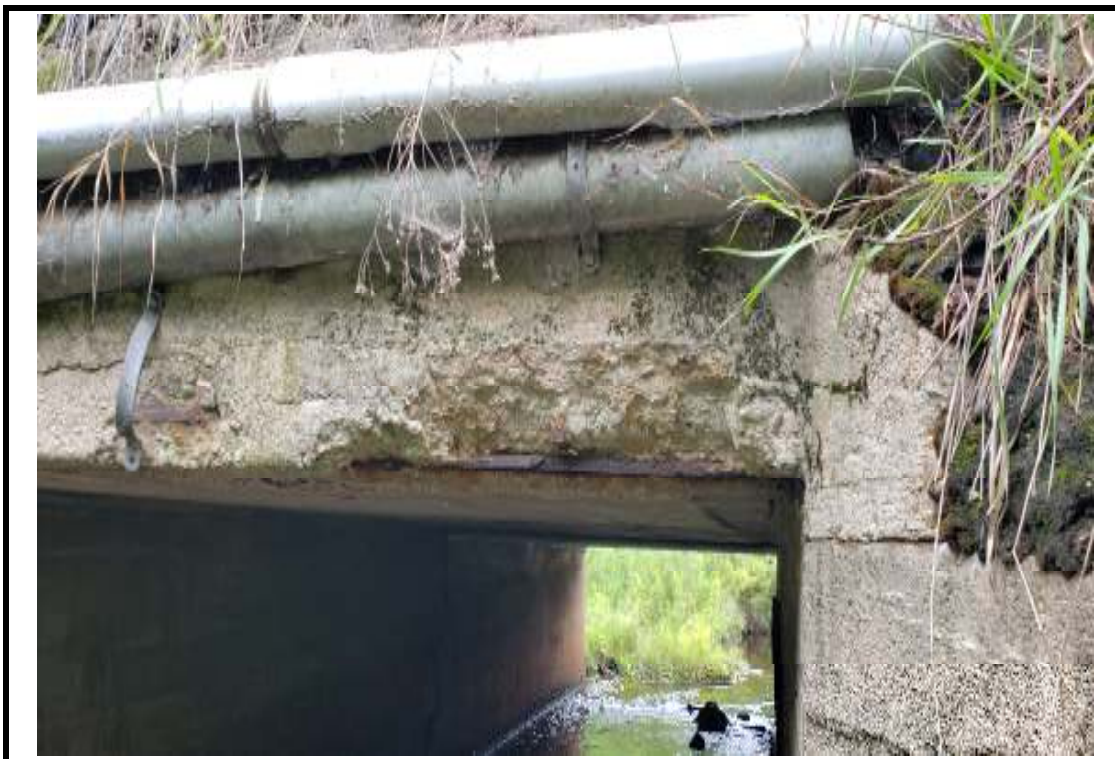
Photo 16 Large spalls with exposed corroded reinforcement noted on south fascia

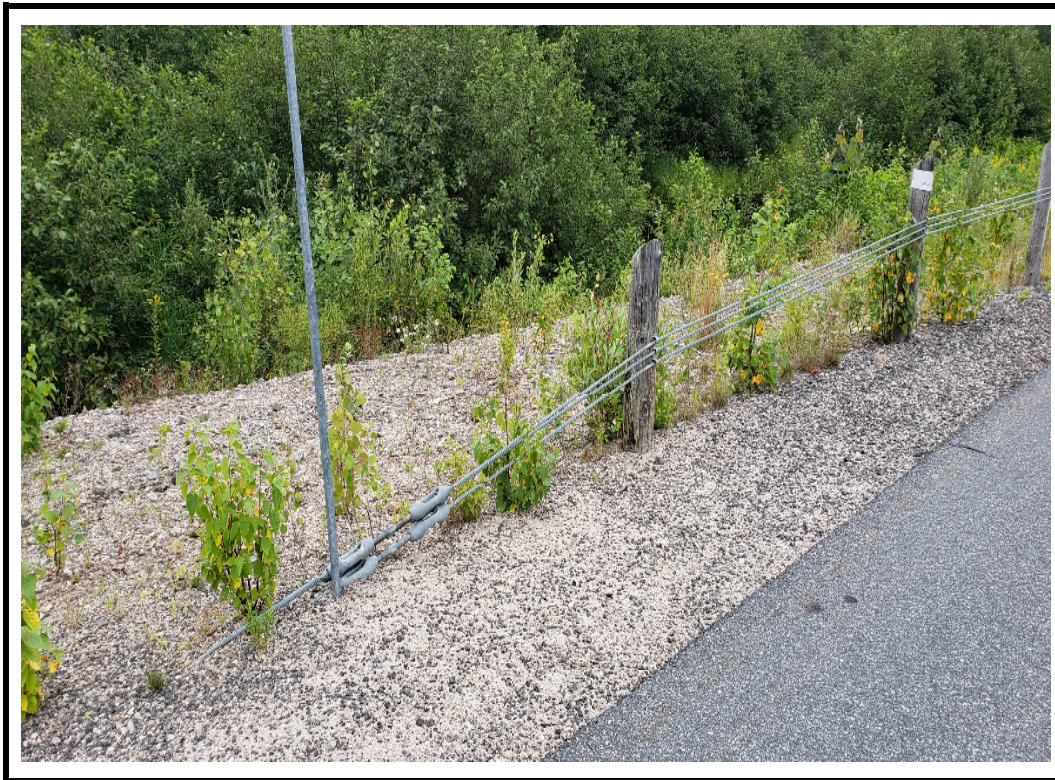
Photo 6 No end treatment present at the time of inspection

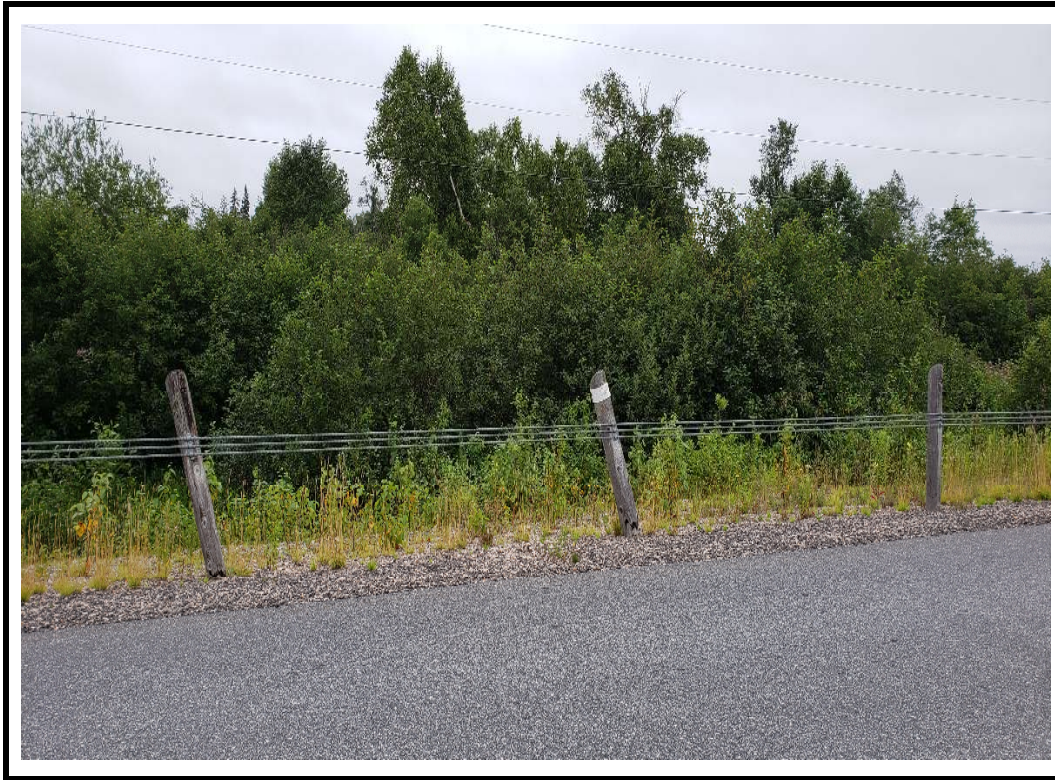
Photo 7 Barrier posts leaning at northeast approach

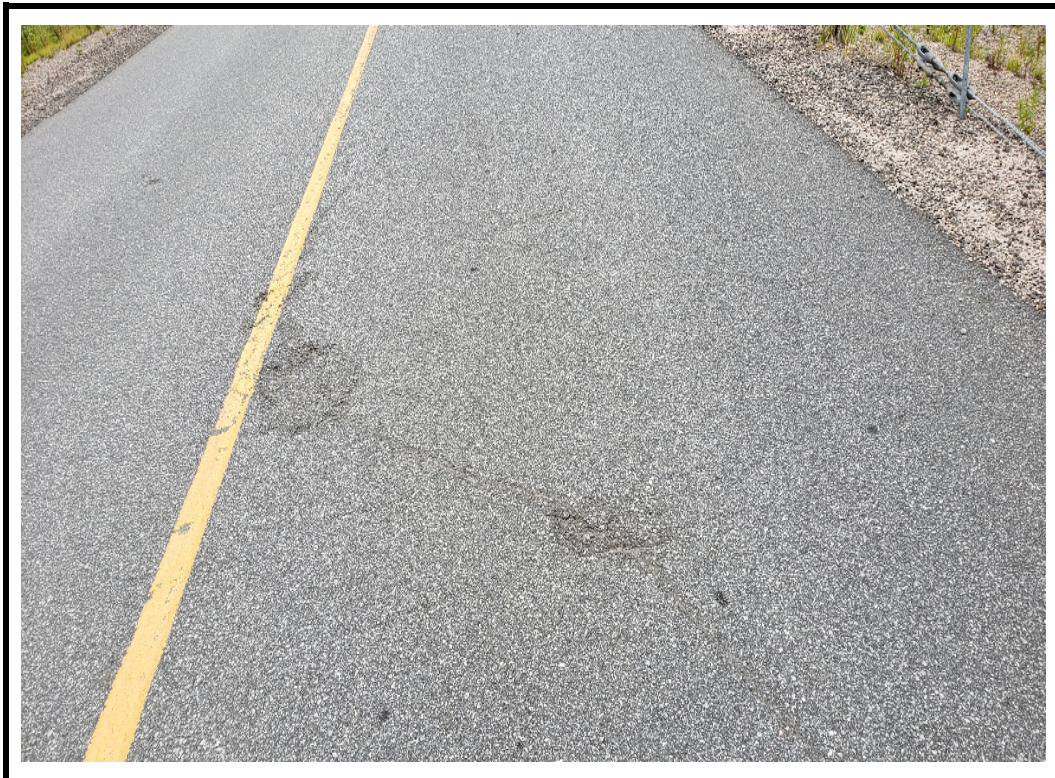
Photo 8 Potholes and previous repairs noted on west approach wearing surface

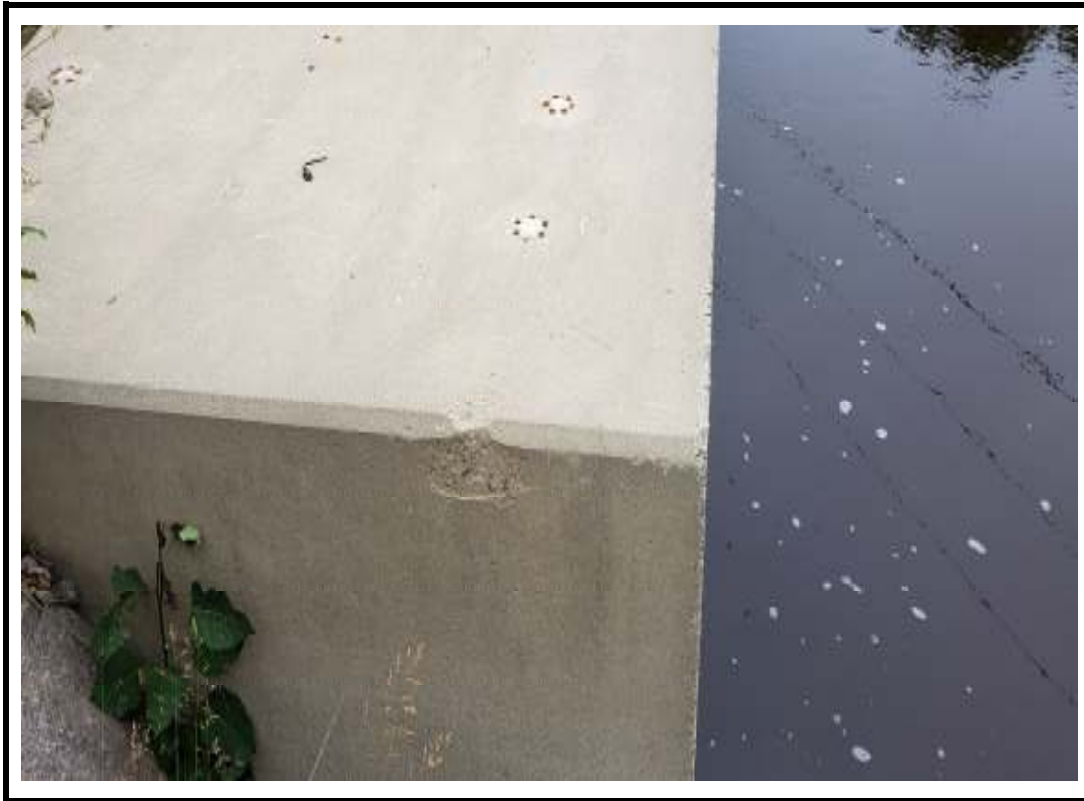
Photo 9 Spall noted on exterior interface of vertical leg and soffit

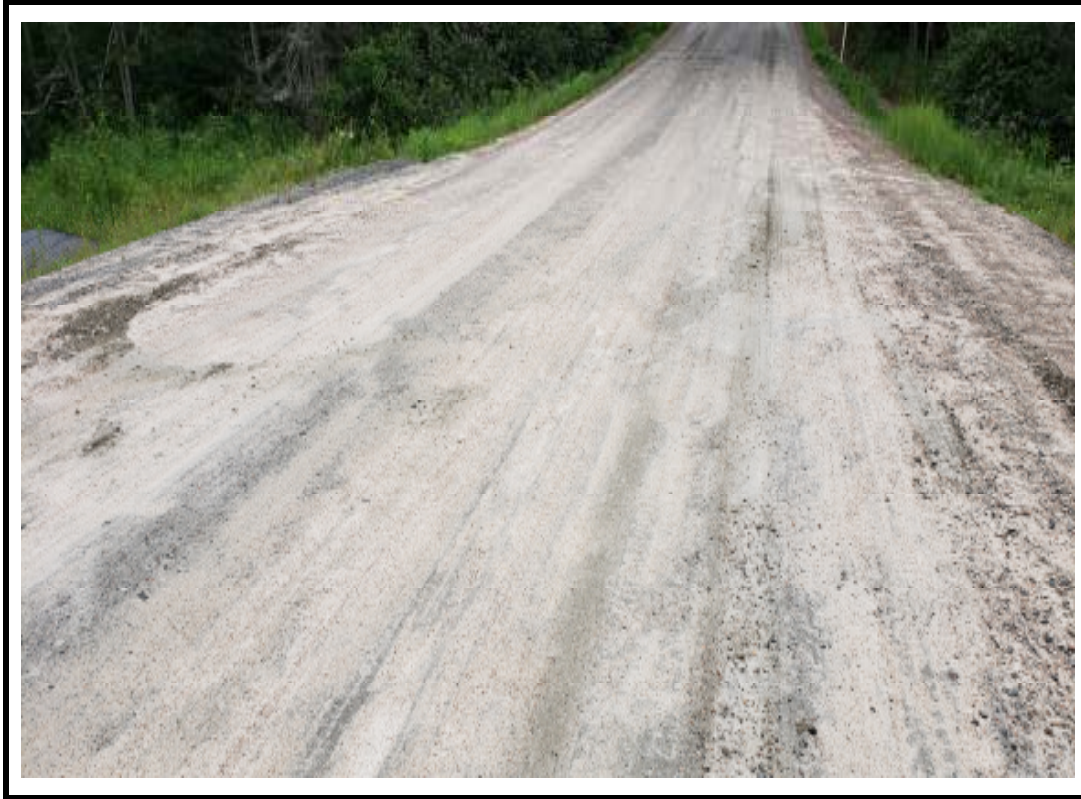
Photo 7 Potholes and loose gravel noted on wearing surface

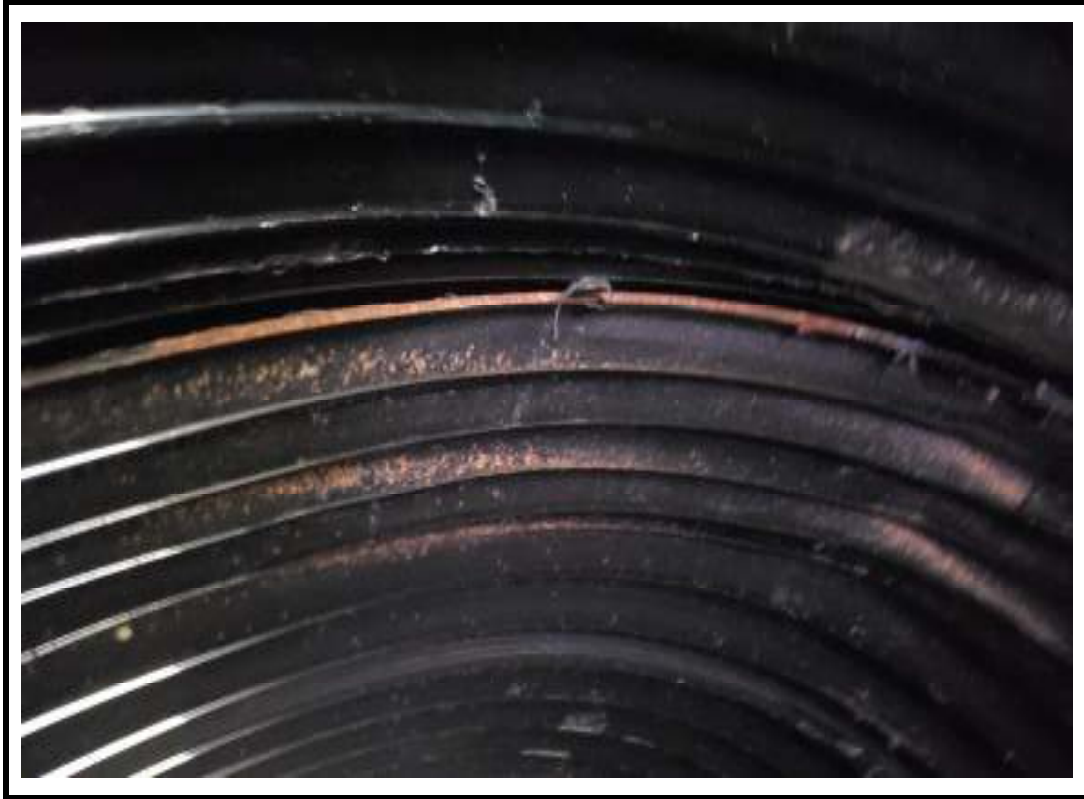
Photo 9 Light corrosion noted inside barrel at joint
